REVISTA MONUMENTELOR ISTORICE

Nr. LXXV, 2006

SAVING SACRED RELICS OF
EUROPEAN MEDIAEVAL CULTURAL HERITAGE

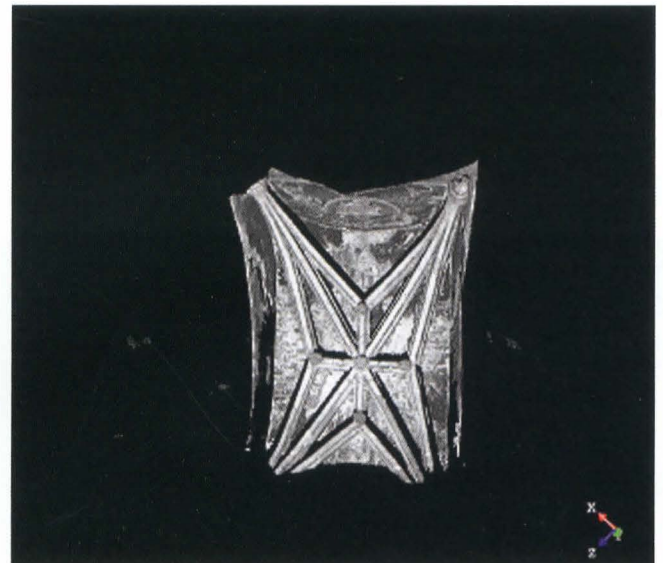
Fig. 3.7 d

Fig 3.7. Different detail of porch's scan

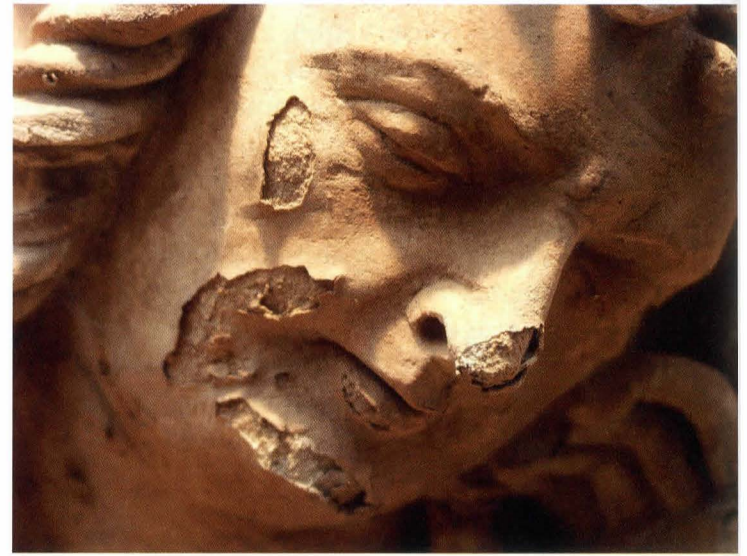
Fig. 5. Sensitive cleaning of scales on a sandstone surface

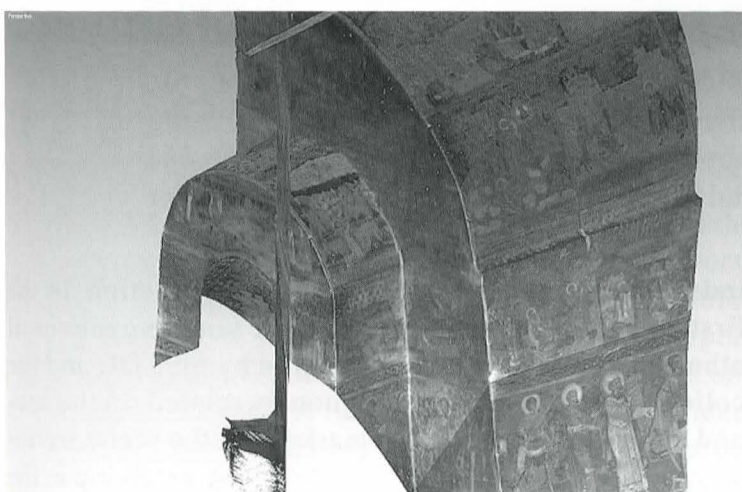
Fig. 3 – Two section of the burial chamber 3D model dressed by the black and white images contemporary collected by the ITR: wall to the right window (upper), wall to the left window (lower).

The model of the entire burial chamber has been acquired and reconstructed, complete with the gray-scale images of the frescoes. Two views are shown as examples in **Fig. 3**, due to the large size of the images collected at high resolution, only reduced data are usually shown after a 90% to 99% decimation. Data have been collected during day and night, acquisitions were started from an height of about 1.80 m, in order to avoid problems re-

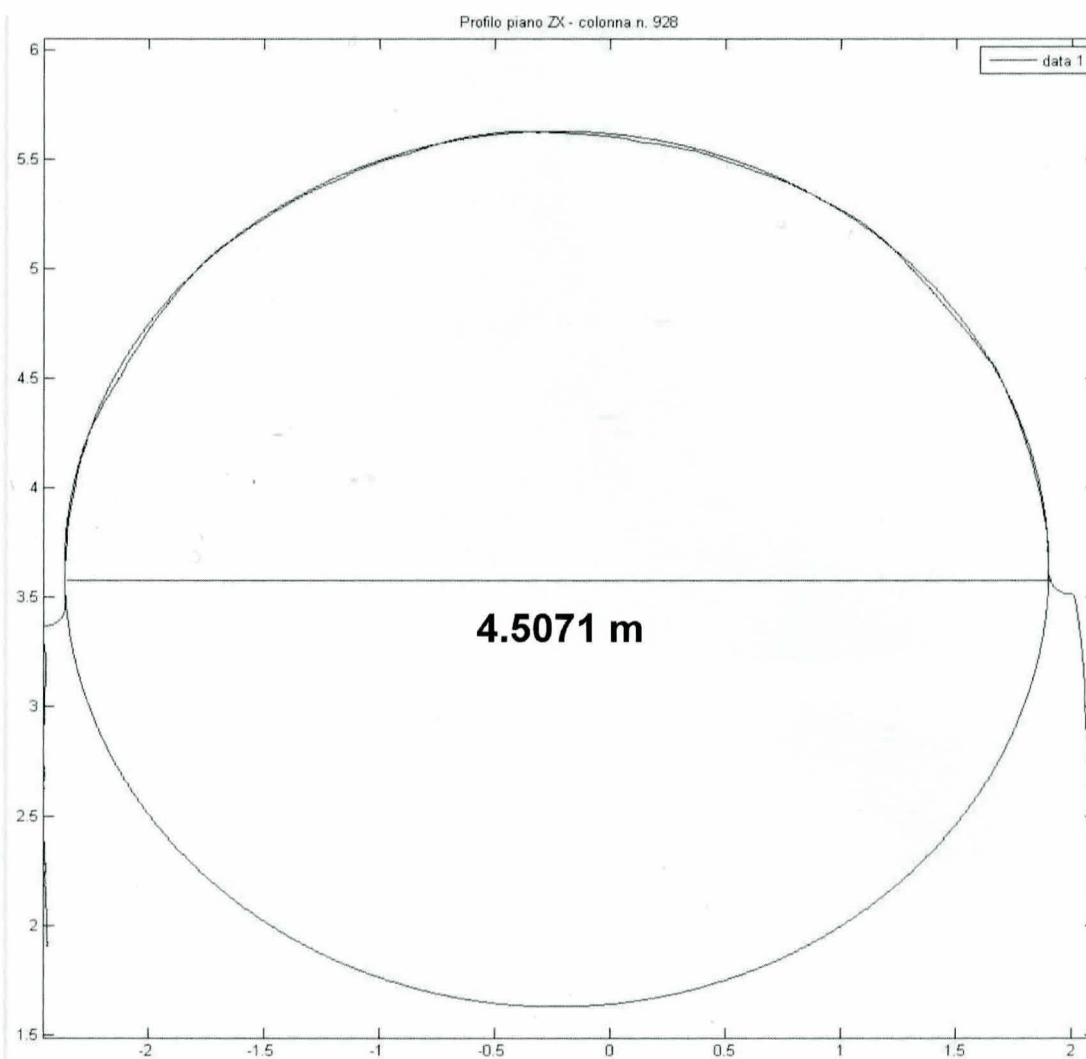
Fig. 6 – A section of one arch on the left wall in the burial chamber as derived from the real model is compared to its mathematical reconstruction corresponding to an ellipsis with the given major axis, the occurrence of discrepancies may be related to the onset of detachment.

3. Architectonic defects ascribable to the original construction or to progressive degradation can be highlighted once the real model is examined in terms of curves of level, or selected sections are compared to the ideal geometrical structure. In **Fig. 5** the image from the front half of the vault is overlaid by isohypses on the model, which highlight details in the construction along with metrical representation. In **Fig. 6** the measured section of a single arch is compared to its mathematical fit with an ellipse having the same major axis diameter. Discrepancies between the real model and the fit function are in this case related to fresco's irregularities which may suggest the need for a restoration action (suspect detachments).

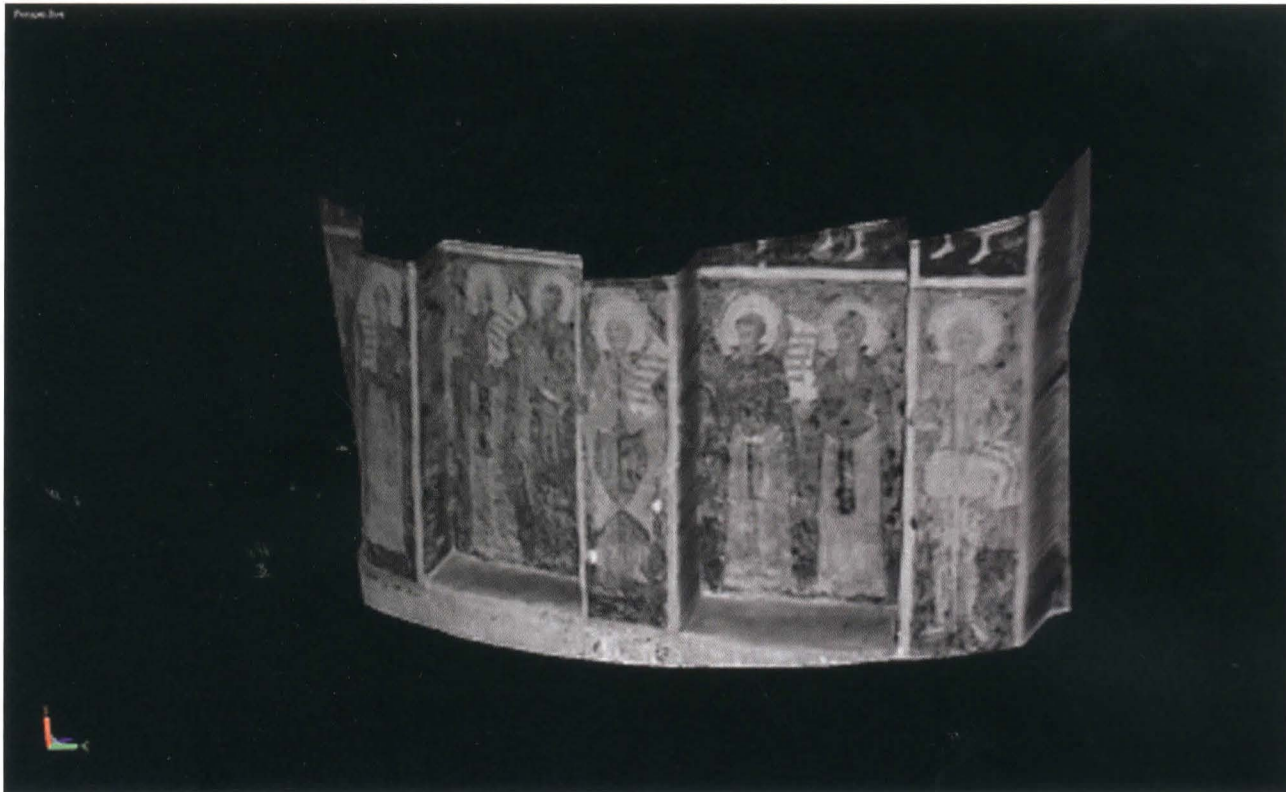
Fig. 8 – 3 D model of portion of the left niche in the outer wall of the absidis. The same area has been scanned by a laser vibrometer [6] looking for structural cracks.

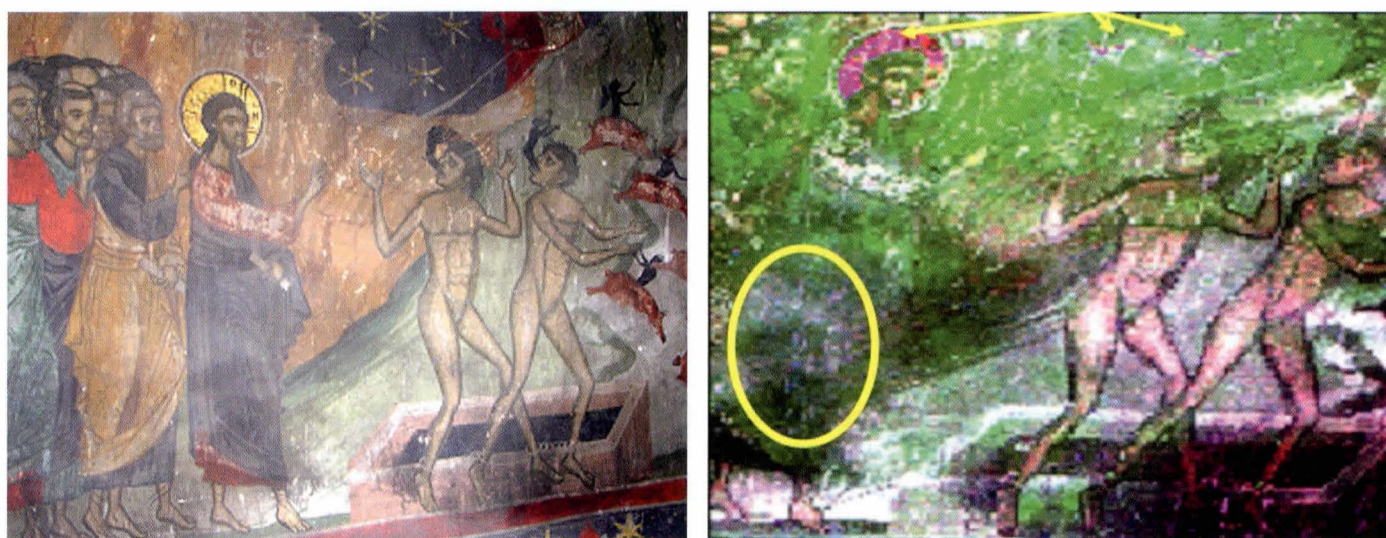
Fig. 4 – Picture of the fresco “Jesus Heals the Demon-Possessed of Gadarenes” (Matthew 8, 28-33) in Sucevita (top). The corresponding false color image (bottom), obtained with the scanning LIF system operating at 266 nm, highlights in dark blue the presence of fungi on the lower part of Christ's dress (circled), conversely the red color of the gilding on the aureole and stars (marked by arrows) does not permit to discriminate the use of paraloid during the restoration.

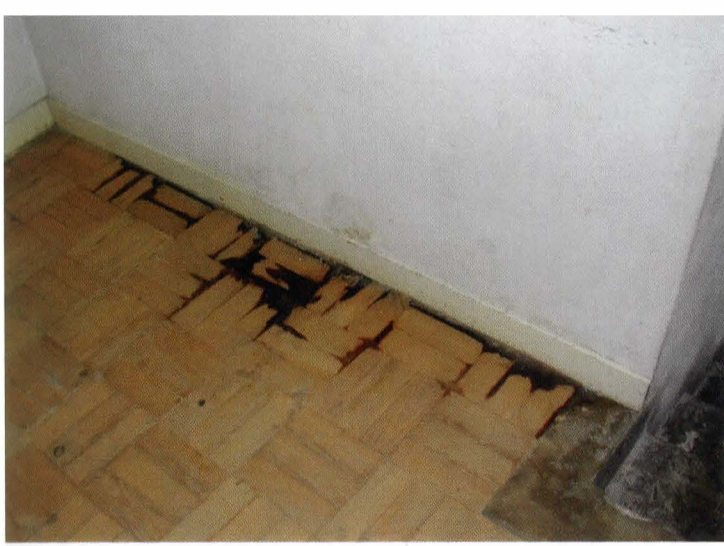
Fig. 1. Humidity in floor

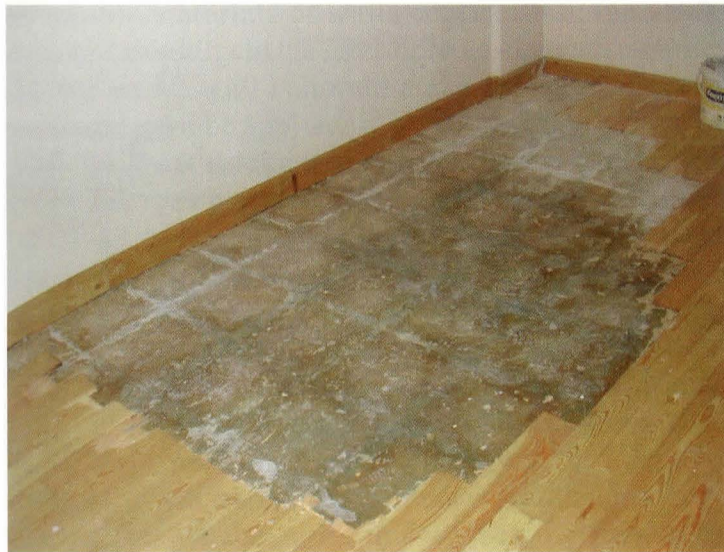
Fig. 2. Damage floor due to humidity

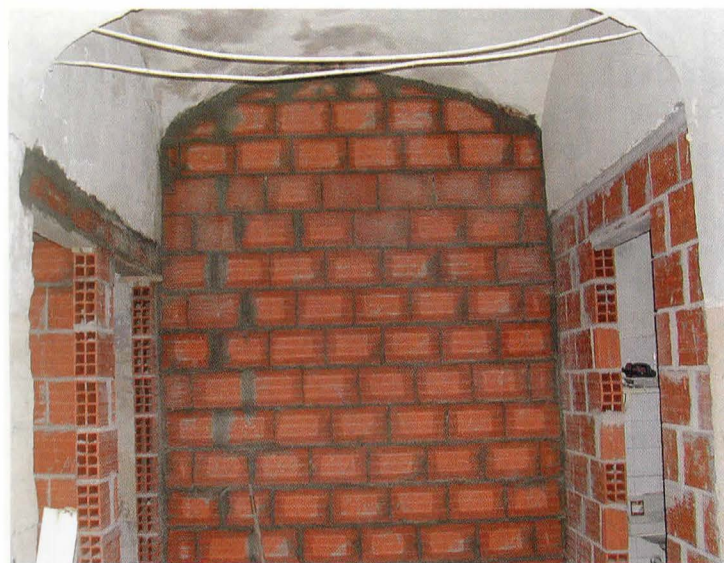
Fig. 3. Construction humidity

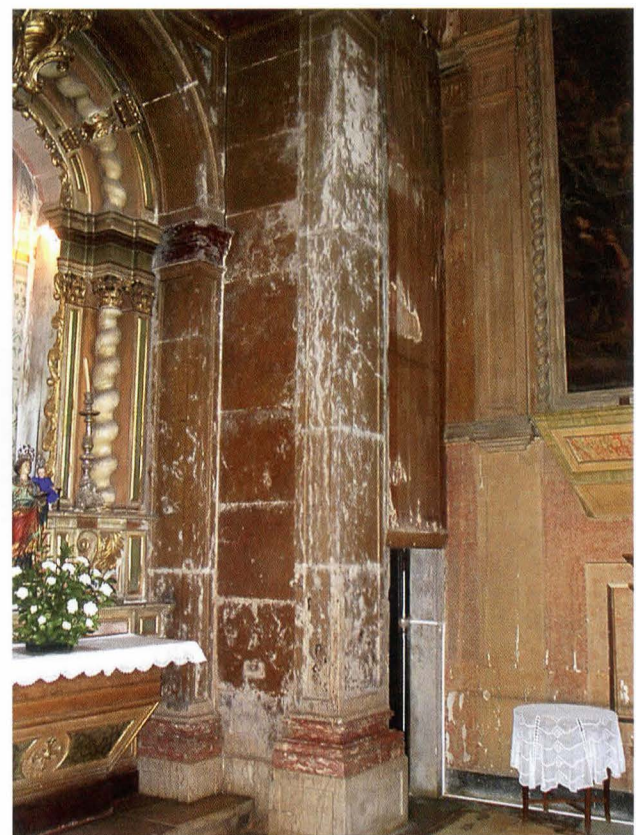
Fig. 4. Ground Humidity

A usually alteration in the moisture content of the ground is when the conditions around the building change due to the application of impermeable materials like bituminous surfaces or hydraulic tiles in the area around the exterior walls in a urban intervention. That alteration prevents the water from the rain to infiltrate to the ground in the same

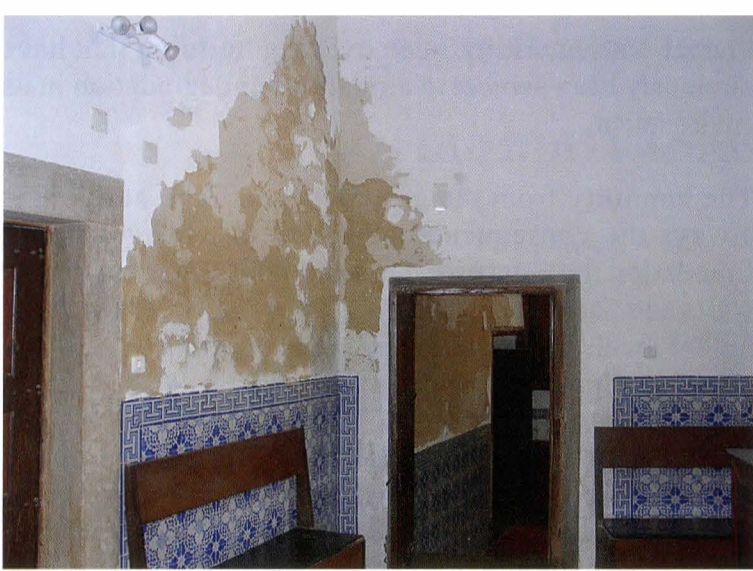
Fig. 5. Damages due to ground humidity

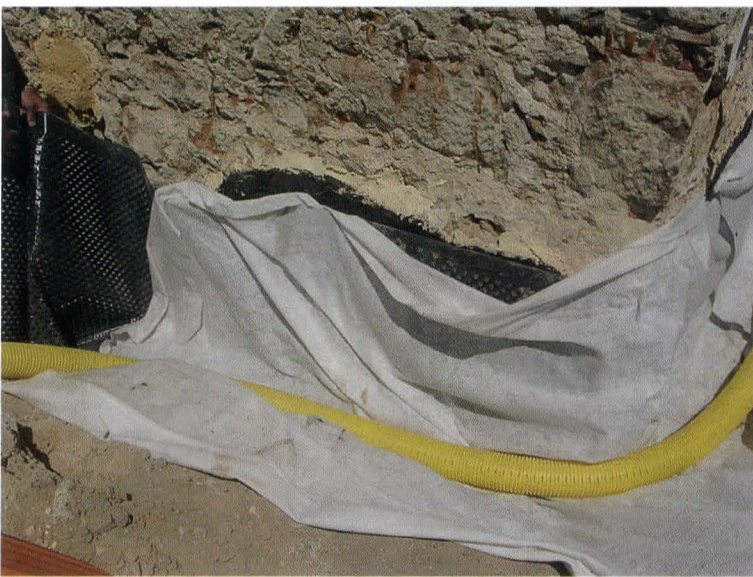
Fig. 6. Geo textil on draining solution

the exterior walls in a sub level of the building with no access on the outside, like the above mentioned situation. In this case one must seriously consider a construction of a second wall on the inside with an efficient draining system in the space between the two walls.

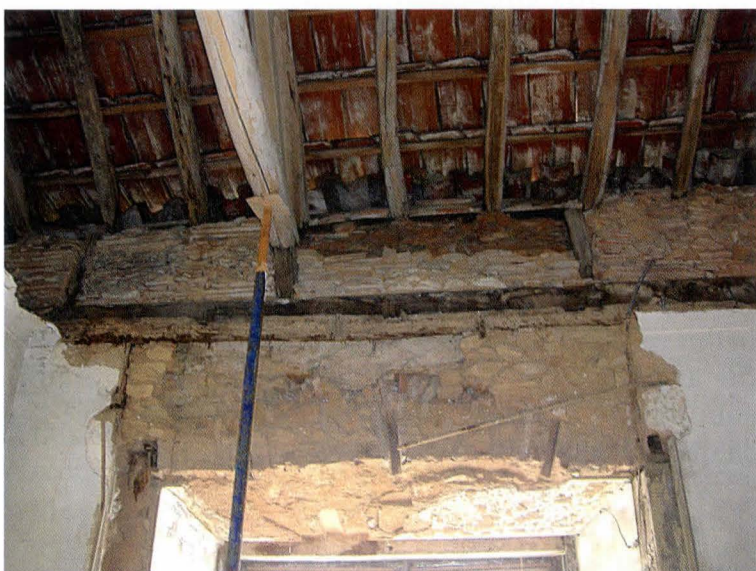
Fig. 11. Damage on structure due to infiltration

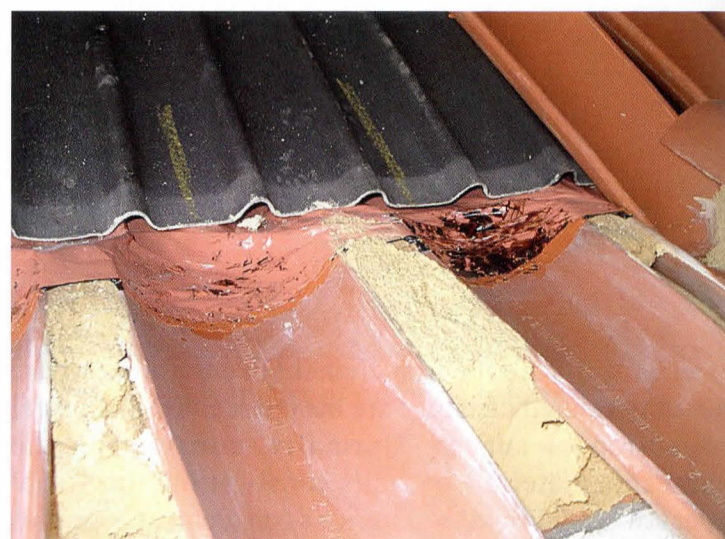
Fig. 13. Rain water protective element

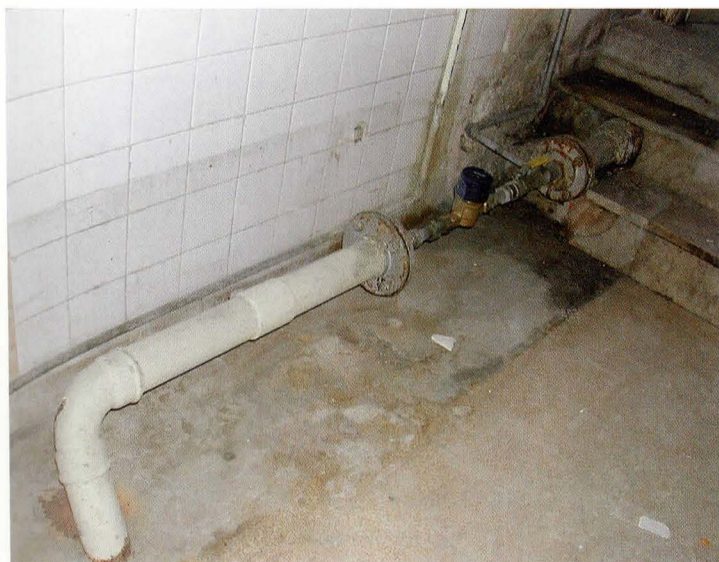
Fig. 14. Water supply pipes with leaks

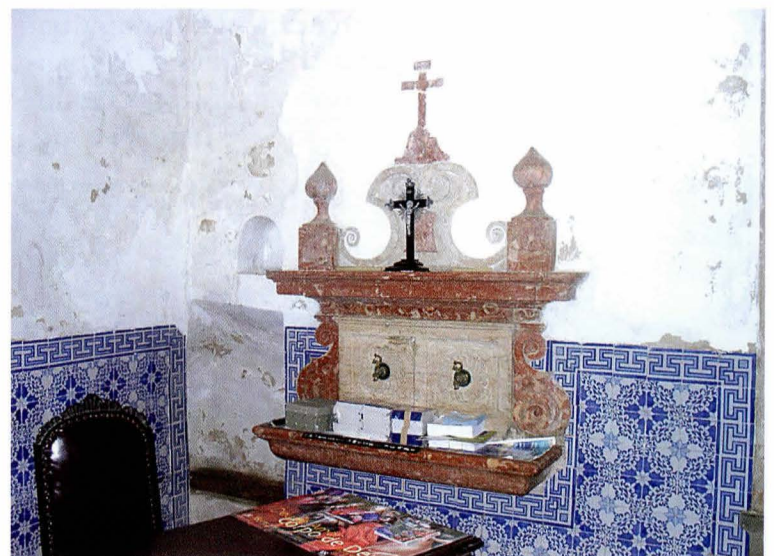
Fig. 15. Efect of condensation water

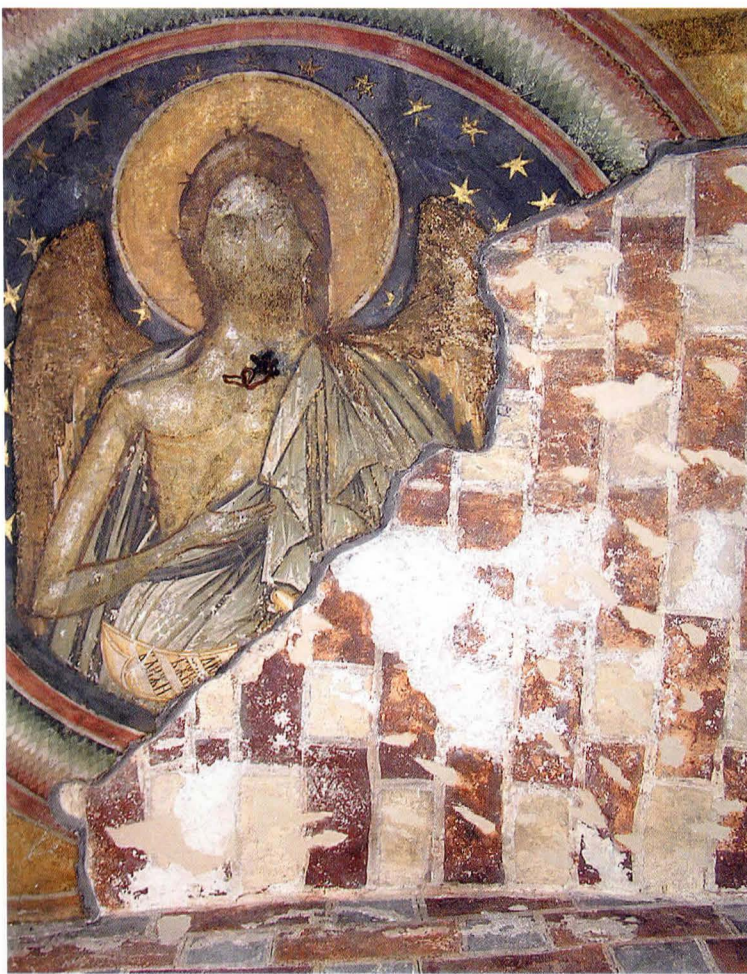
Fig. 4. The two painted layers of the church

- *the second wall decoration, is a painting accomplished „a fresco”* applied over the first decoration. This painting layer covers great part of the church, but there are also some empty spaces, especially on the vaults because of the infiltration moisture.

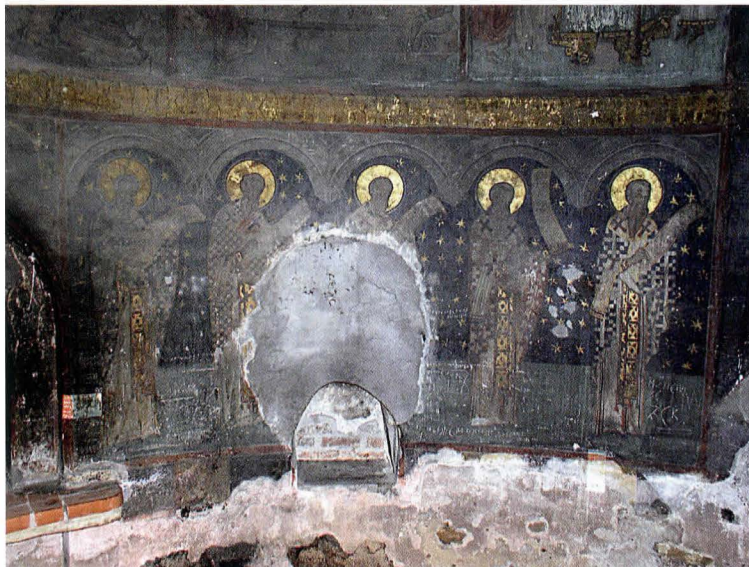
Fig. 13. Chancel. Inside. Degradation and loss of the painting due to capillarity moisture

Moisture measurements undertaken inside the church indicates a high level of humidity reaching values superior to 8,6 in altar, nave and pronaos, up to a height of 2,00 m, diminishing in height (Fig. 13). As a consequence of capillarity moisture, on the lower part can be noticed a loss of the support layer cohesion due to the mechanical action of the salt crystallisation process. In the higher part, on the domes, vaults and archways, big areas affected by moisture of infiltration and a loss of the support layer adherence can be noticed.

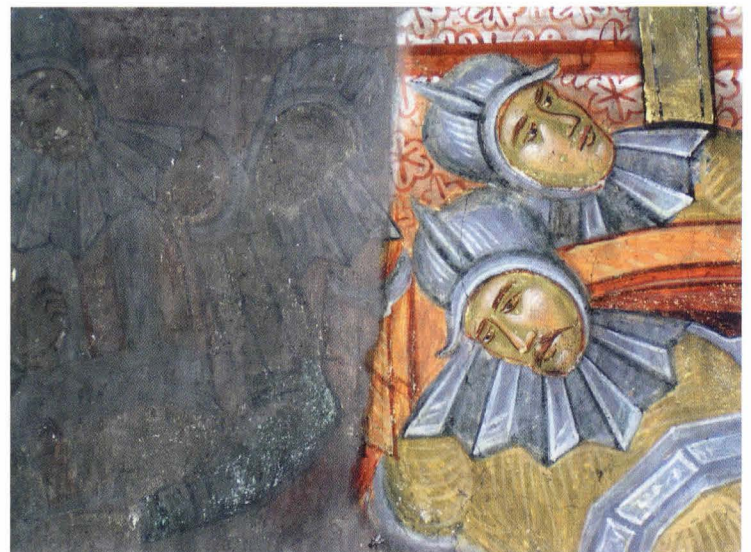
Fig. 15. Comparative zones during the cleaning

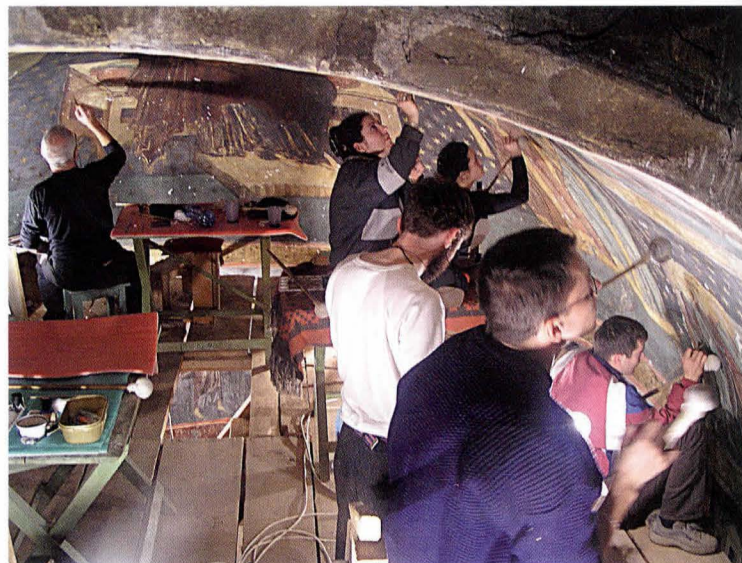
Fig. 26. During the restoration process

The aesthetic presentation problems, as the final stage of restoration, showed us great incomplete surfaces as a result of the colour layer degradation. The white areas of various forms and sizes were differently approached, according to their problems. Thus, the colour erosions were chromatically integrated in the *velatura* technique by using neutral wash-tints of paint-wash (Fig. 25, 26).

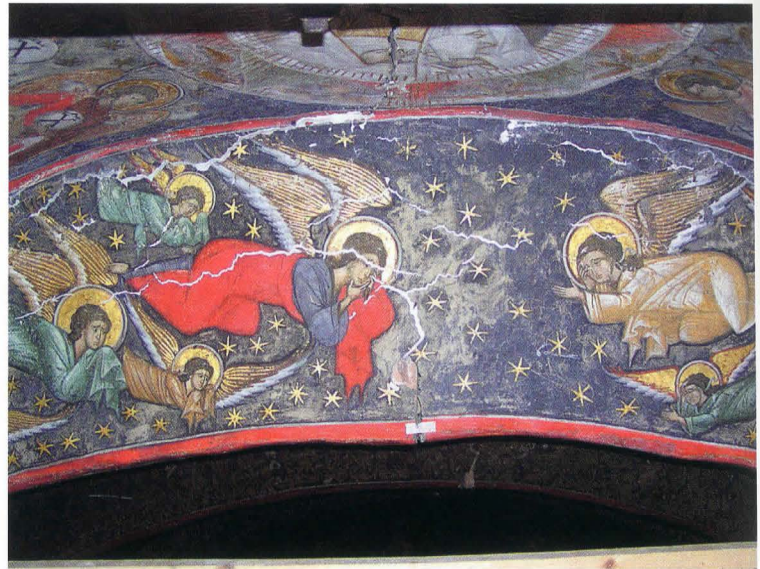
Fig. 13. Triumph arch : cracks and detachments coming from the structure

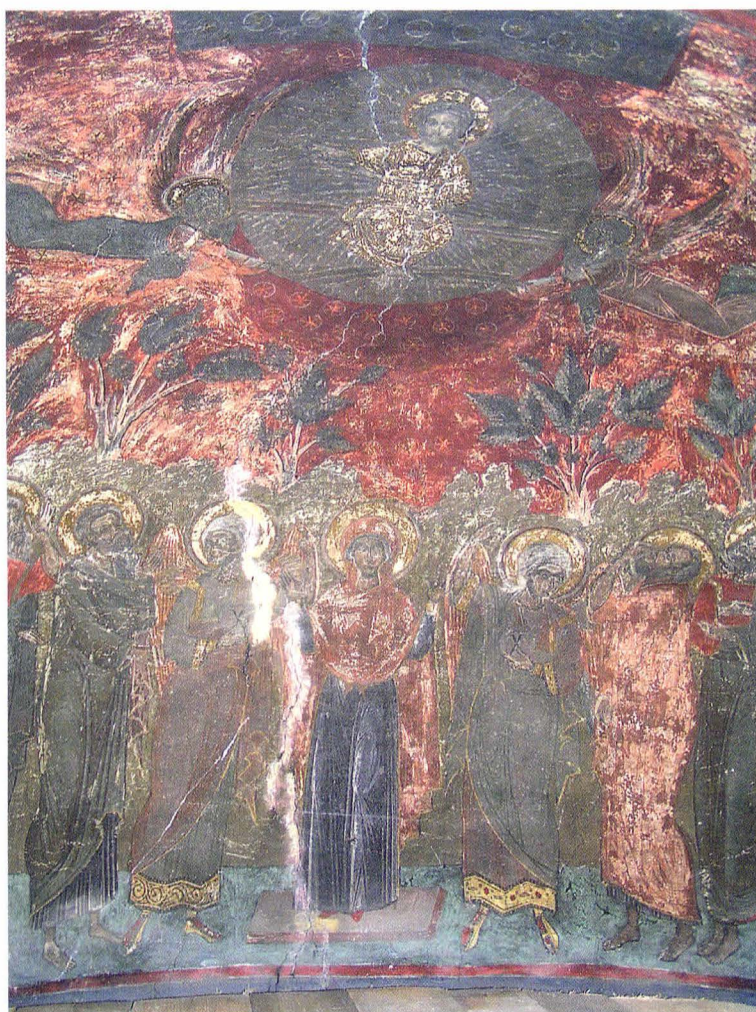
Fig. 15. Chancel, semicupola. Cracks and detachments

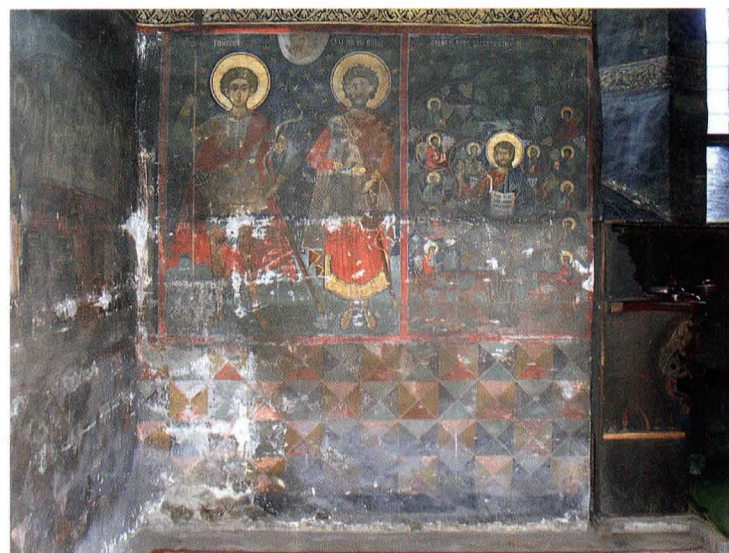
Fig. 16. Nave. Murals damages due to erosion

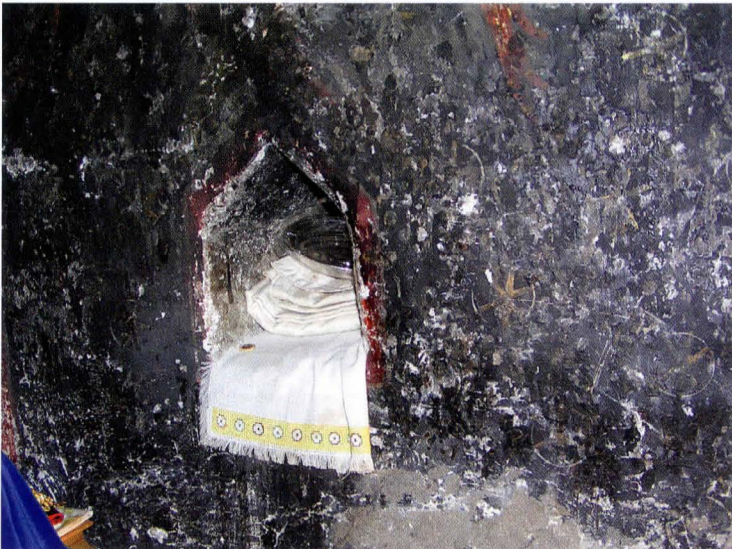
Fig. 19. Deposits on the painting in the diaconicon

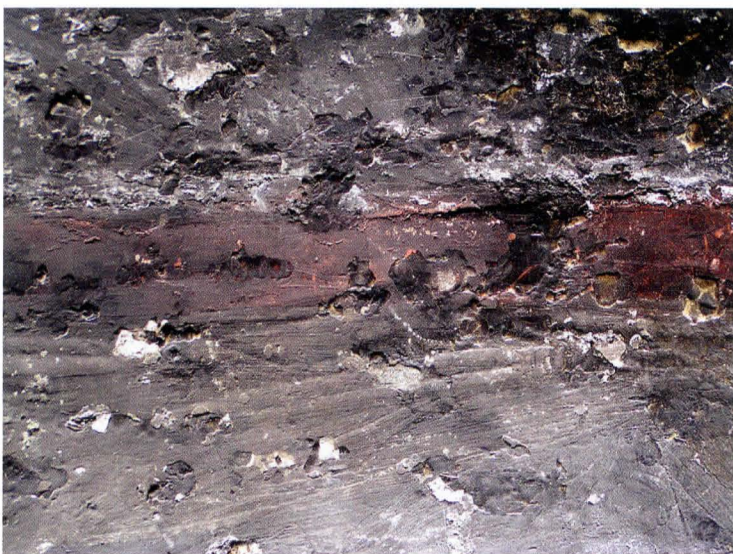
Fig. 20. Deposits on the painting in the diaconicon

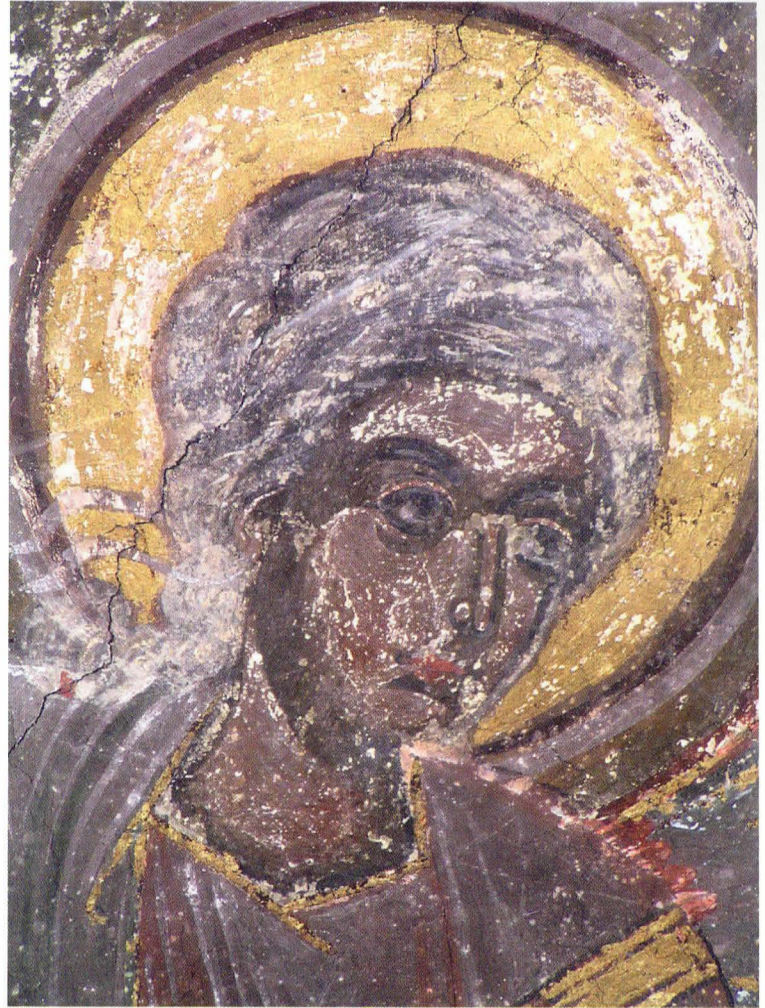
Fig. 21. Decohesion of the mural painting, before restoration

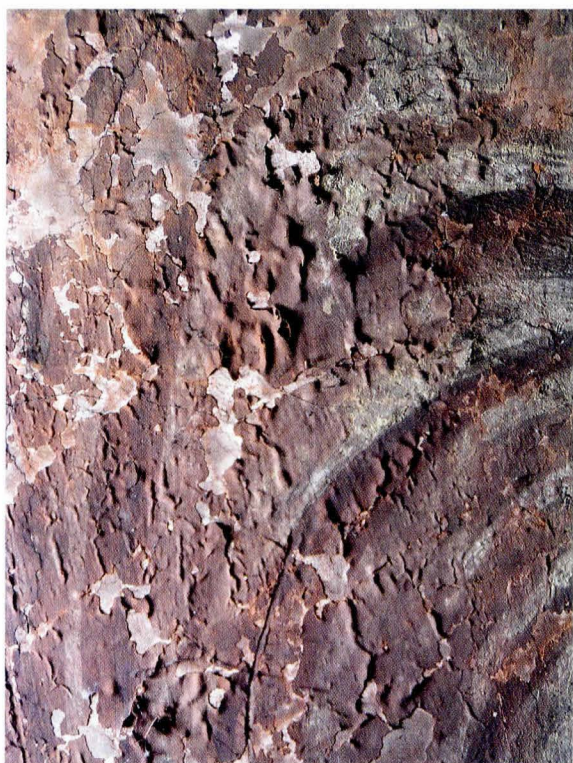
Fig. 26. Loss of adherence of the paint layer

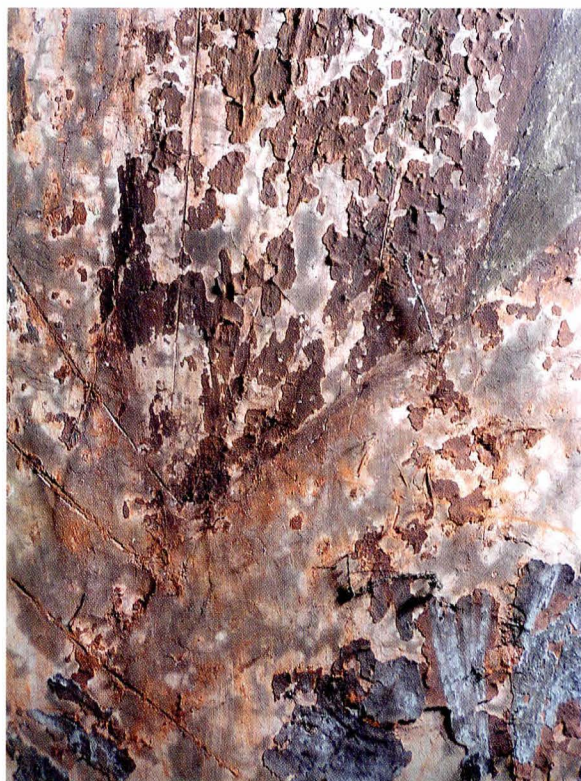
Fig. 27. Loss of adherence of the paint layer

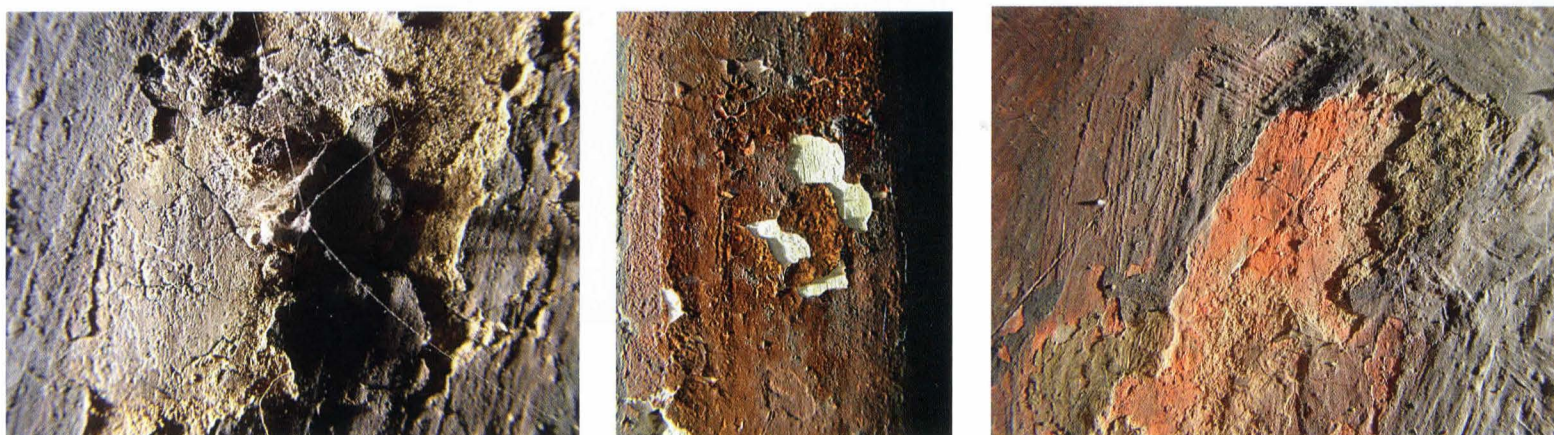
Fig.3. Loss of adhesion of the paint layer in its thickness or on the intonaco support

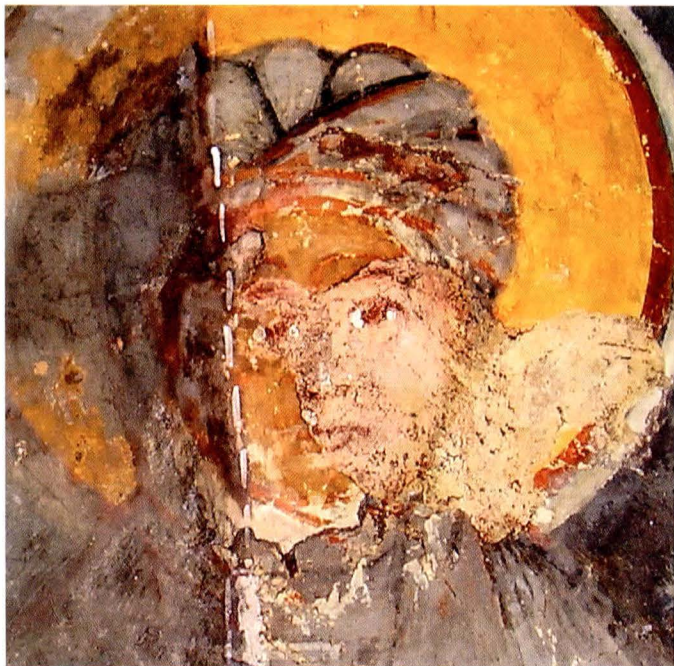
Fig. 9. Overlapped overpainting of the portrait

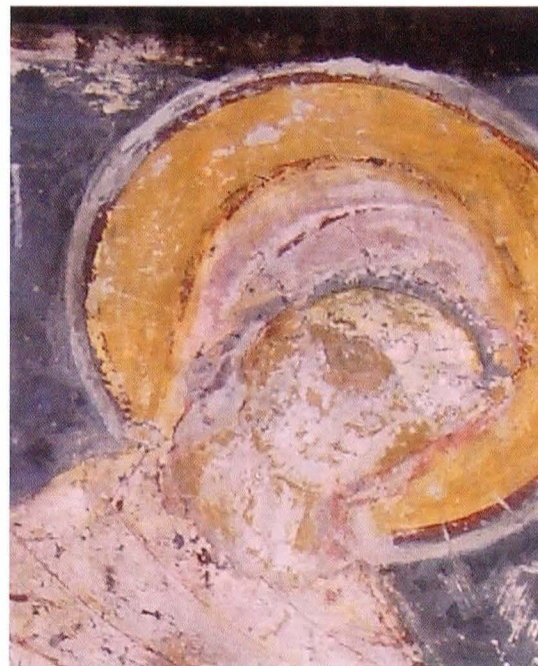
Fig. 10. Total overpainting of the portrait

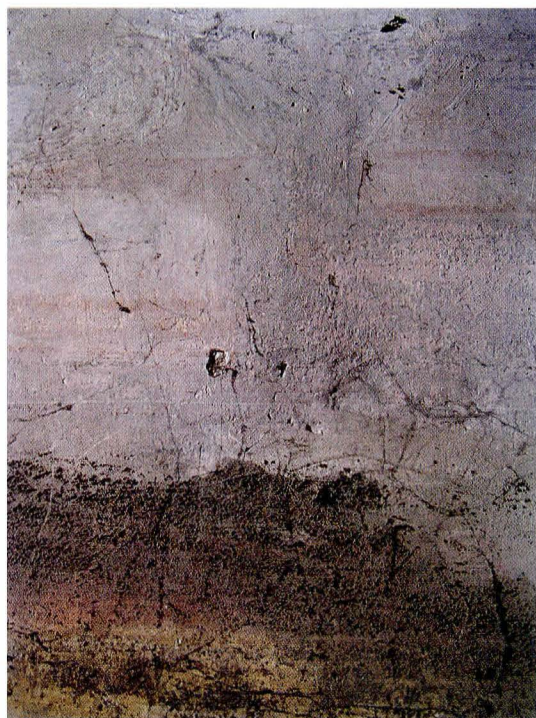
Fig. 16. Non-adherent deposits on the surface of the painting, together with paint layer showing lack of cohesion
